Manhole Inspection Summary

Manhole # S31EE_019MH

Location Address: **MASON ST**

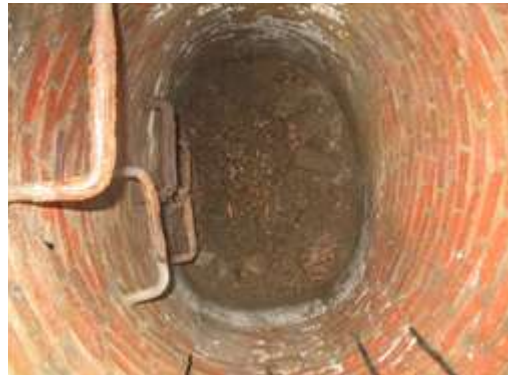
Top View

Corroded steps. Channel debris.

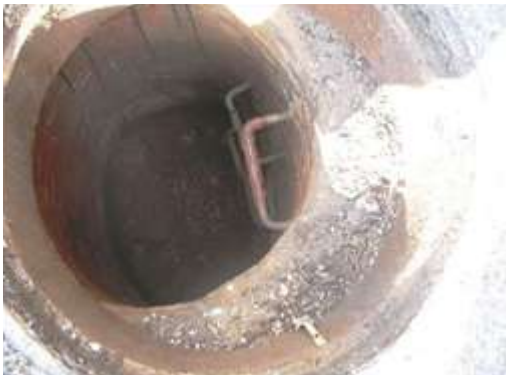
Defect

Frame leaks. Frame offset. Adjustment deterioration and infiltration. Corbel and Barrel infiltration.

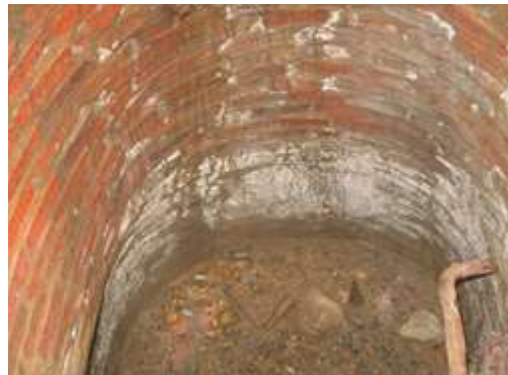
Defect

Barrel infiltration.

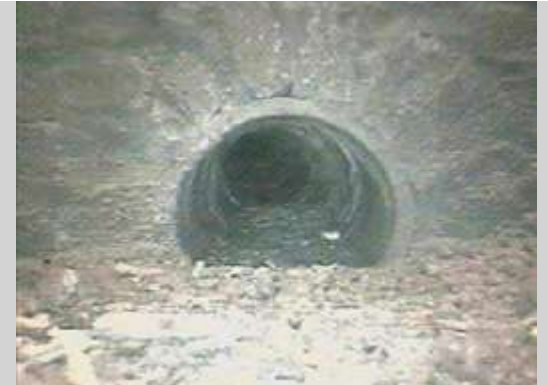
8 in. Circular Gravity Sewer
Pipe Out @ 12 O'Clock

Deposits: ☐ None ☒ **Mud** ☐ Sludge ☒ **Debris** ☐ Grease

Silt Depth: **1** (in.) Deposits Extent: **Light**

Pipe Seal Cond: **Cracked**
